Nixalite® Project Case History

Name: Orlando International Airport

Location: Orlando, Florida

Product: Stainless Steel Welded Wire Mesh

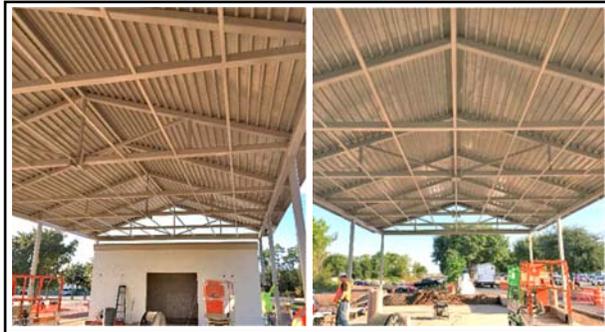
The Orlando International Airport erected an equipment shelter to help protect equipment and personnel from the harsh Florida sun and rain. Unfortunately, pest birds found the shelter to their liking as well.

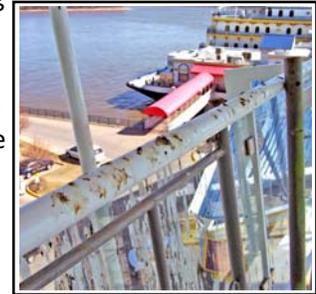
Pest birds love open steel framing. Their droppings can corrode steel!

Bird droppings are corrosive and pose a serious health hazard.

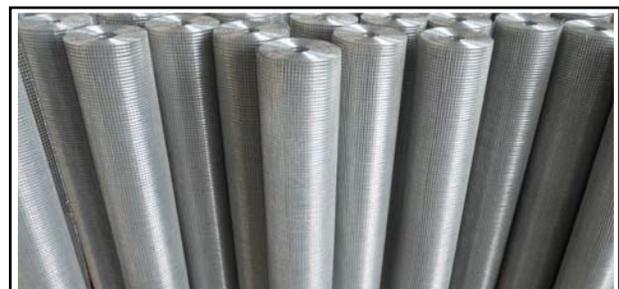
Nixalite offers a full line of Bird Screen Welded Wire Mesh Barriers. Available in both galvanized steel and stainless steel, wire mesh has unlimited uses. It can be cut, molded and formed to fit complex shapes

After talking with Mr. Aponte and reviewing the bid specifications, Nixalite suggested installing the Bird Screen Stainless Steel Welded Wire Mesh Barriers. It would be installed under the lowest structural steel beams to seal off all areas that would end up behind the barrier. Based on the dimensions provided for the structure and the specific requirements of the bid, it was determined that Nixalite's 1/2" square opening, all stainless steel wire mesh barrier was the product that best fit the application and specification.

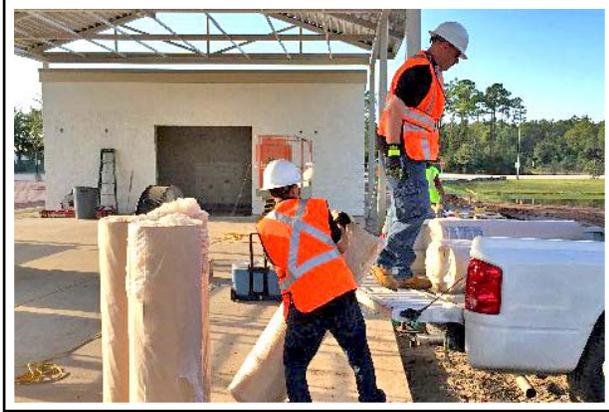
Based on the dimensions provided by Home Care Pest Control and the written specs for the bid, it was determined that 8 rolls of the stainless steel wire mesh would be needed for the enclosure.

Based on the measurements provided by Home Care Pest Control, it was determined that a total of eight rolls (4' wide and 100' long) of the stainless steel wire mesh were needed to complete the job. Home Care Pest Control installed the stainless steel wire mesh with locally purchased hardware and stainless steel wire ties supplied by Nixalite.

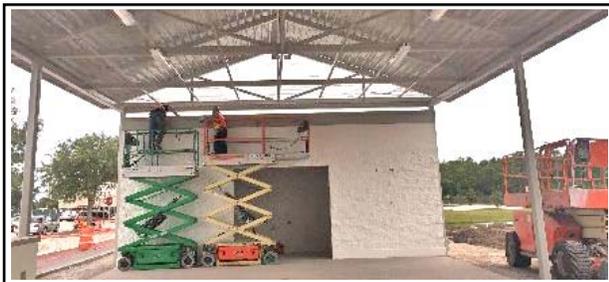
The stainless steel welded wire mesh was expertly installed by Home Care Pest Control. Their attention to detail and ingenuity served them well.

David Aponte of Home Care Pest Control chose to install the stainless steel welded wire mesh with stainless steel fasteners and support cables. The fasteners were a self-drilling and self-tapping screws with rubber washers. These were installed through the mesh and into the steel behind. To further secure the mesh, Home Care Pest Control installed cables beneath the wire mesh to help hold it secure to the underside of the open steel framing. They used the stainless steel wire ties from Nixalite to join the wire mesh together along the edges and seams. This method of joining the individual runs of wire mesh together created a seamless and smooth look to the finished installation.

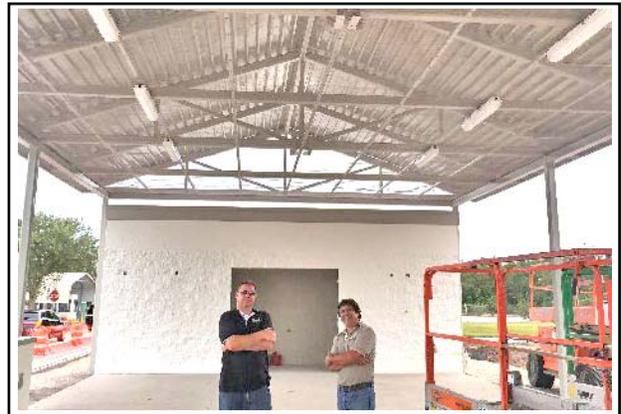
Both David Aponte (right) and his installation crew are justifiably proud of the installation. Patience and attention to detail paid the benefits of a wire mesh installation that is both inconspicuous and perfectly executed.
